HISTORIC STRUCTURE REPORT

ST. PHILOMENA CATHOLIC CHURCH

KALAUPAPA NATIONAL HISTORICAL PARK
Molokai, Hawaii

January 1985

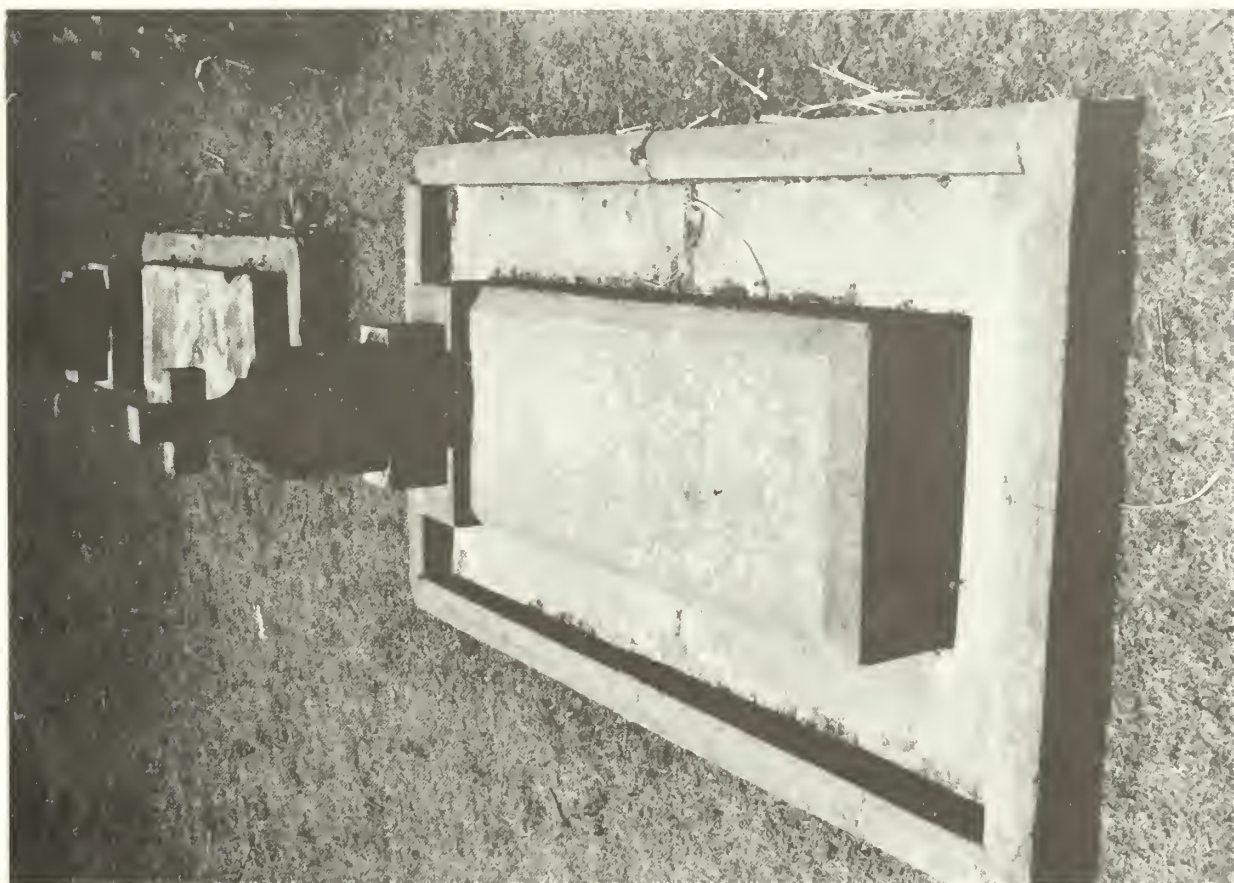
Illustration A131.

Grave of W.K. Cunha, died June 28, 1925
(No. 11 on Site Plan drawing). 8/84.

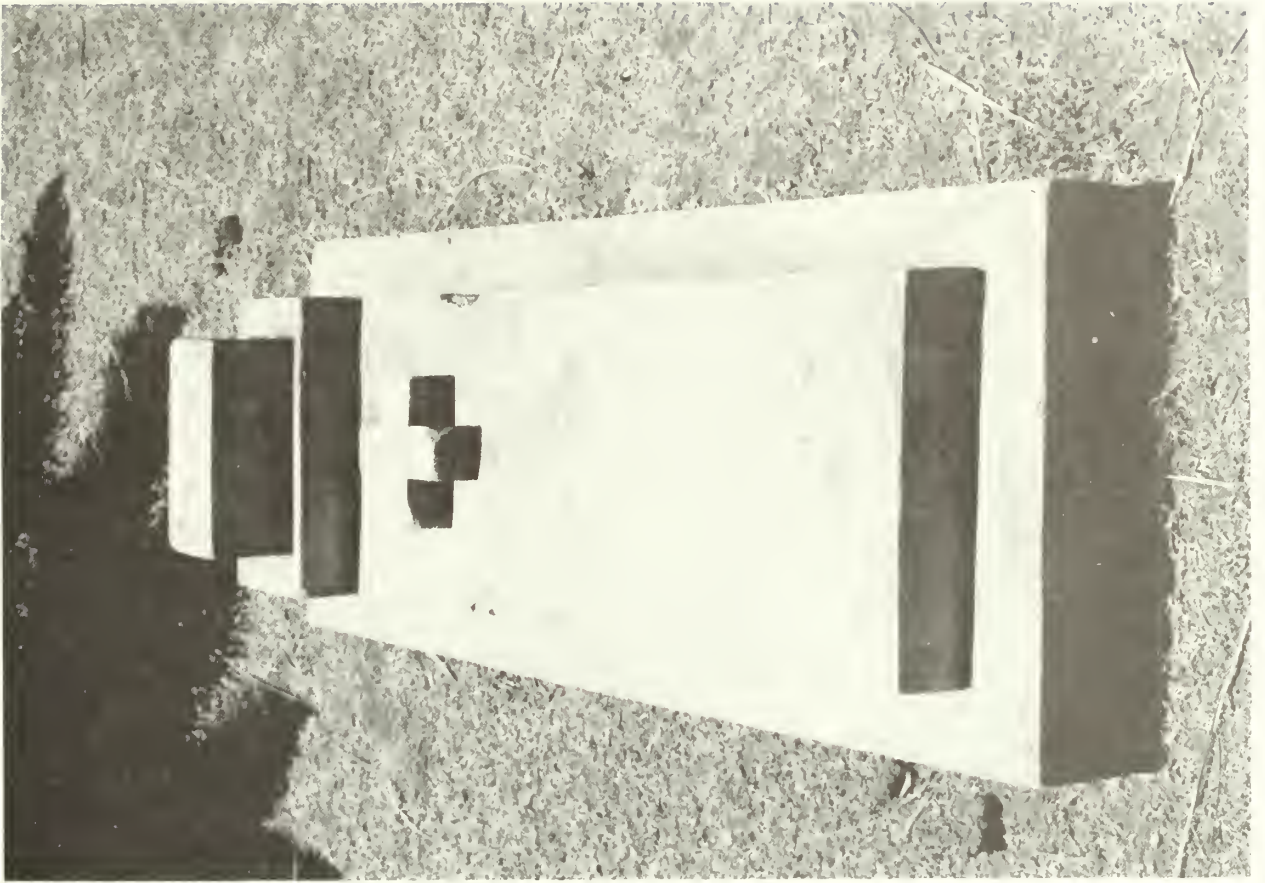
Illustration A132.

The person buried here was unidentified as the headstone is missing (grave No. 12 on Site Plan drawing). 8/84. P.C.C.

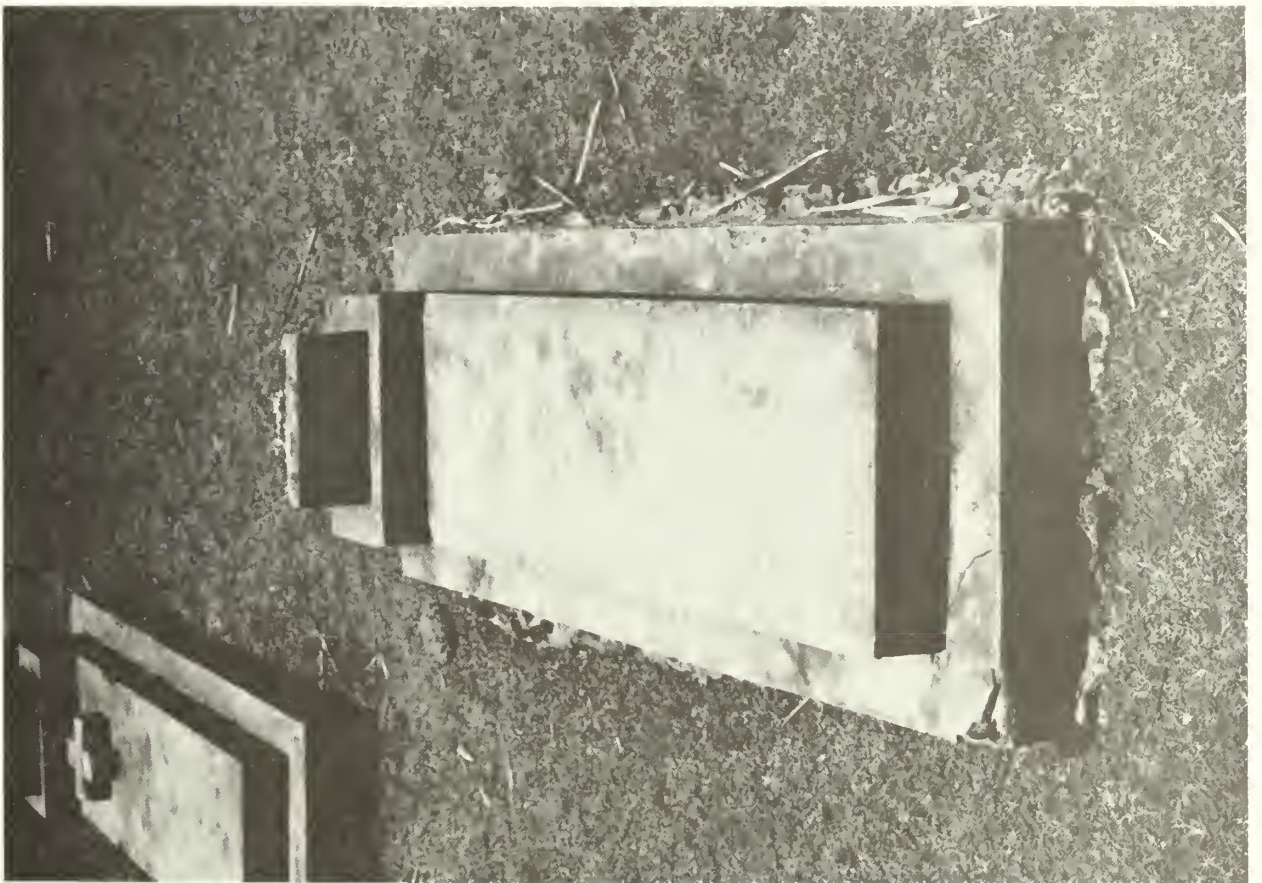
Illustration A133.

Also unidentified as headstone is broken (No. 13 on Site Plan drawing). 8/84. P.C.C.

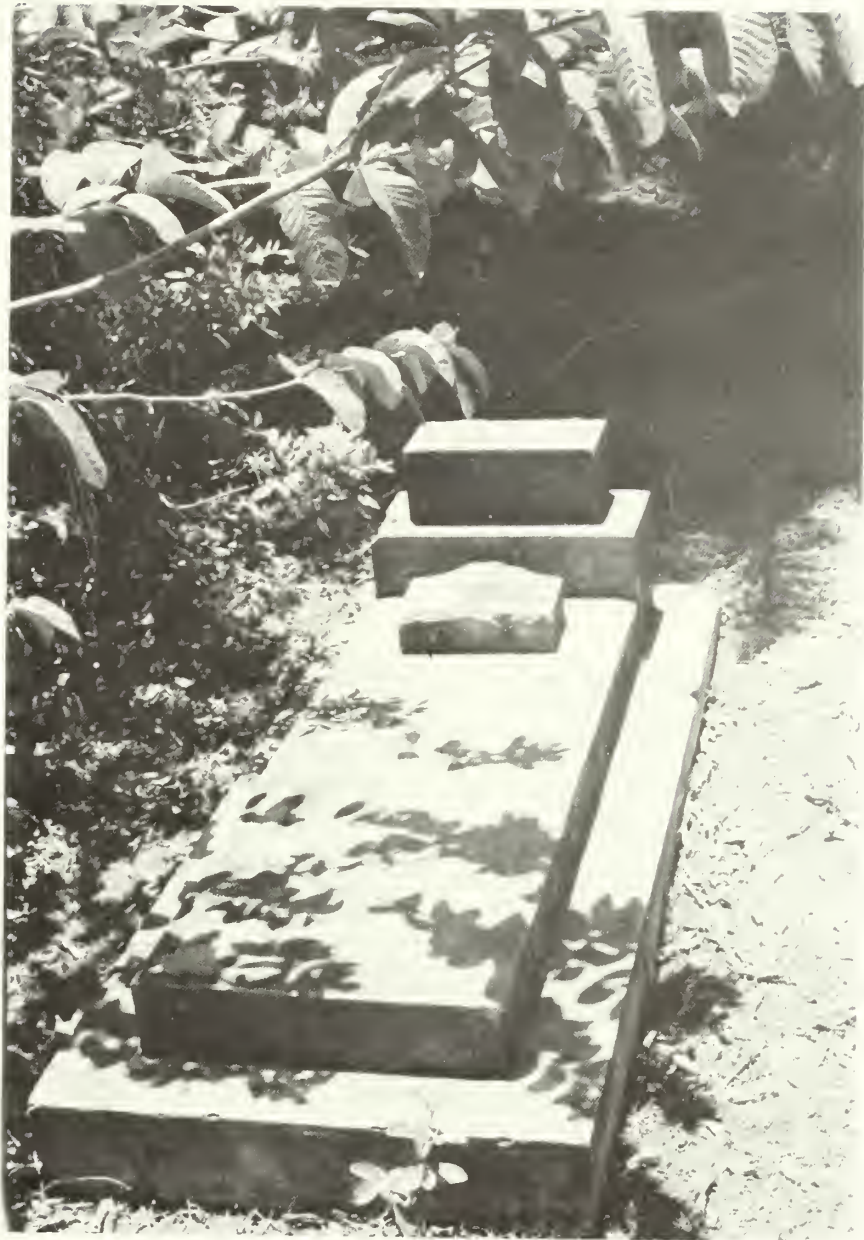
Illustration A134. Grave of Jos. Barete, died Nov. 20, 1920 (No. 14 on Site Plan drawing). 8/84. P.C.C.

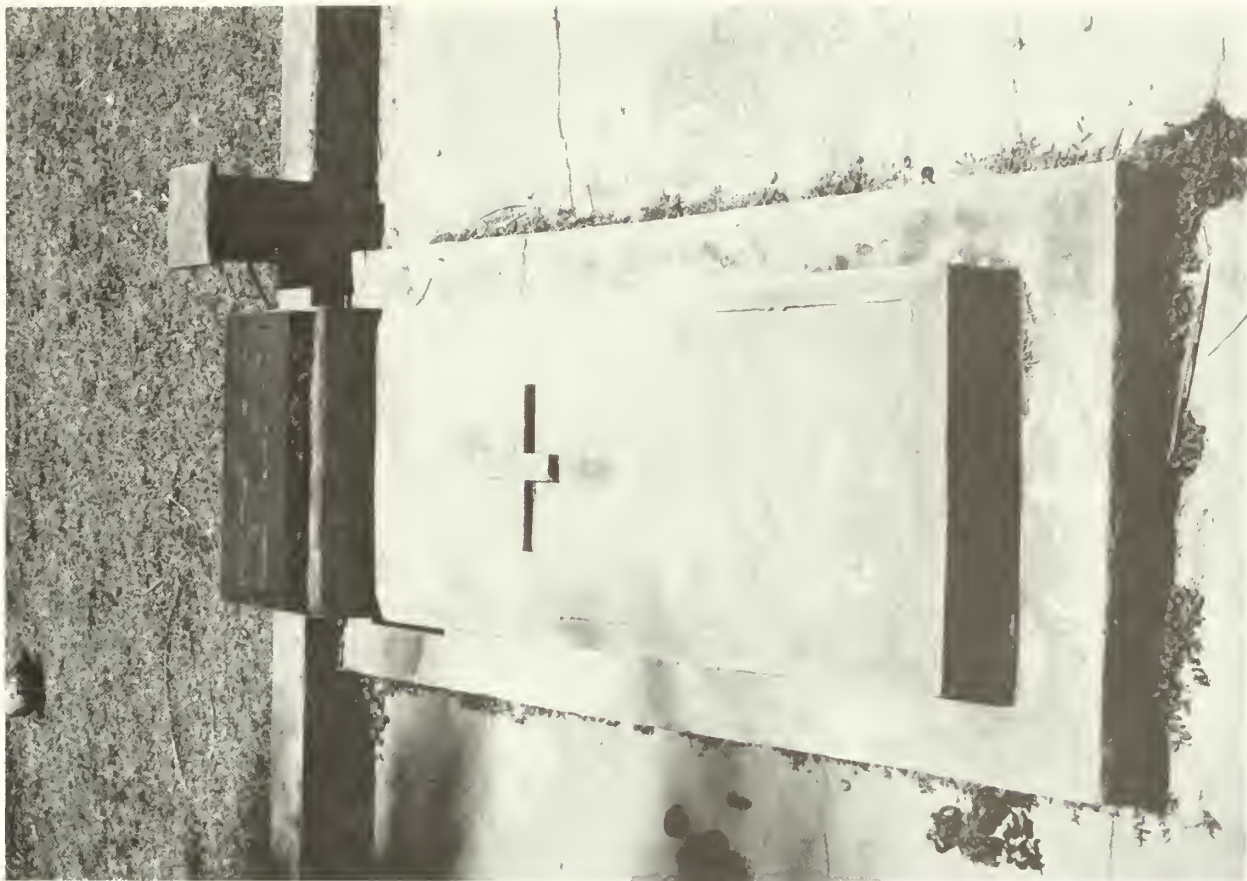
Illustration A135.

Grave of Br. Rochus Rech, Nov. 10,
1902 (No. 15A on Site Plan drawing).
8/84. P.C.C.

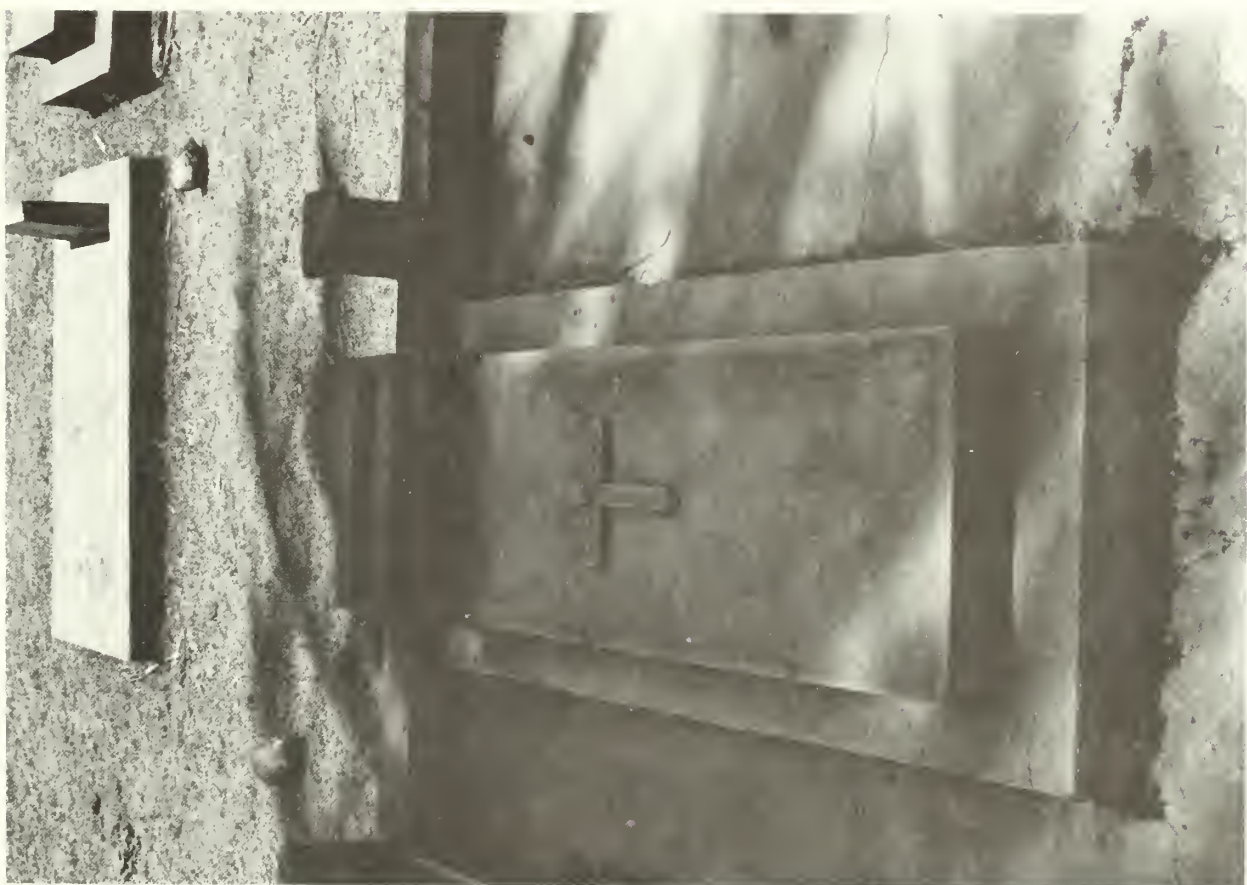
Illustration A136.

Grave of Br. Victor Schumpf, Feb. 20,
1900 (No. 15B on Site Plan drawing).
8/84. P.C.C.

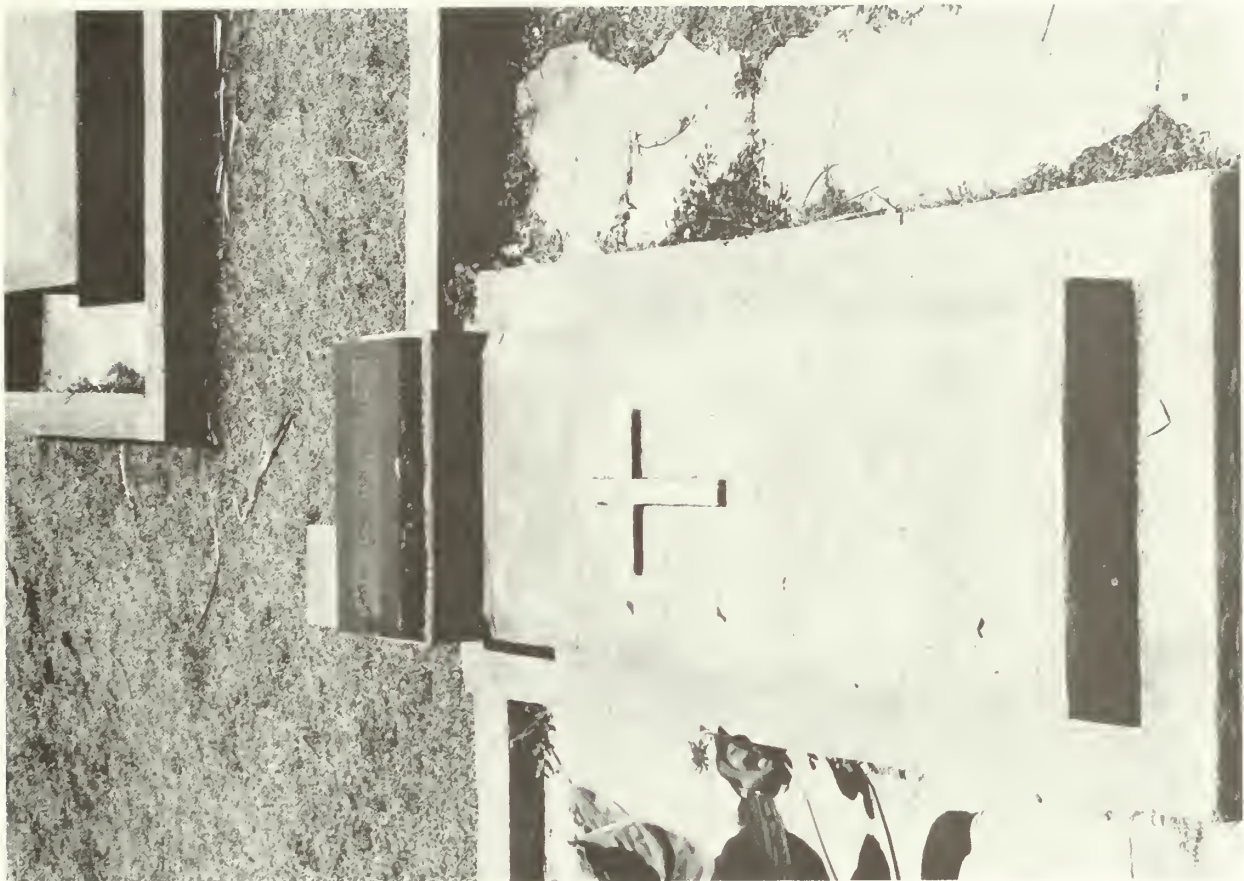
Illustration A137.

Br. Maria Serapion Van Hoof, May 12,
1910 (No. 15C on Site Plan drawing).
8/84. P.C.C.

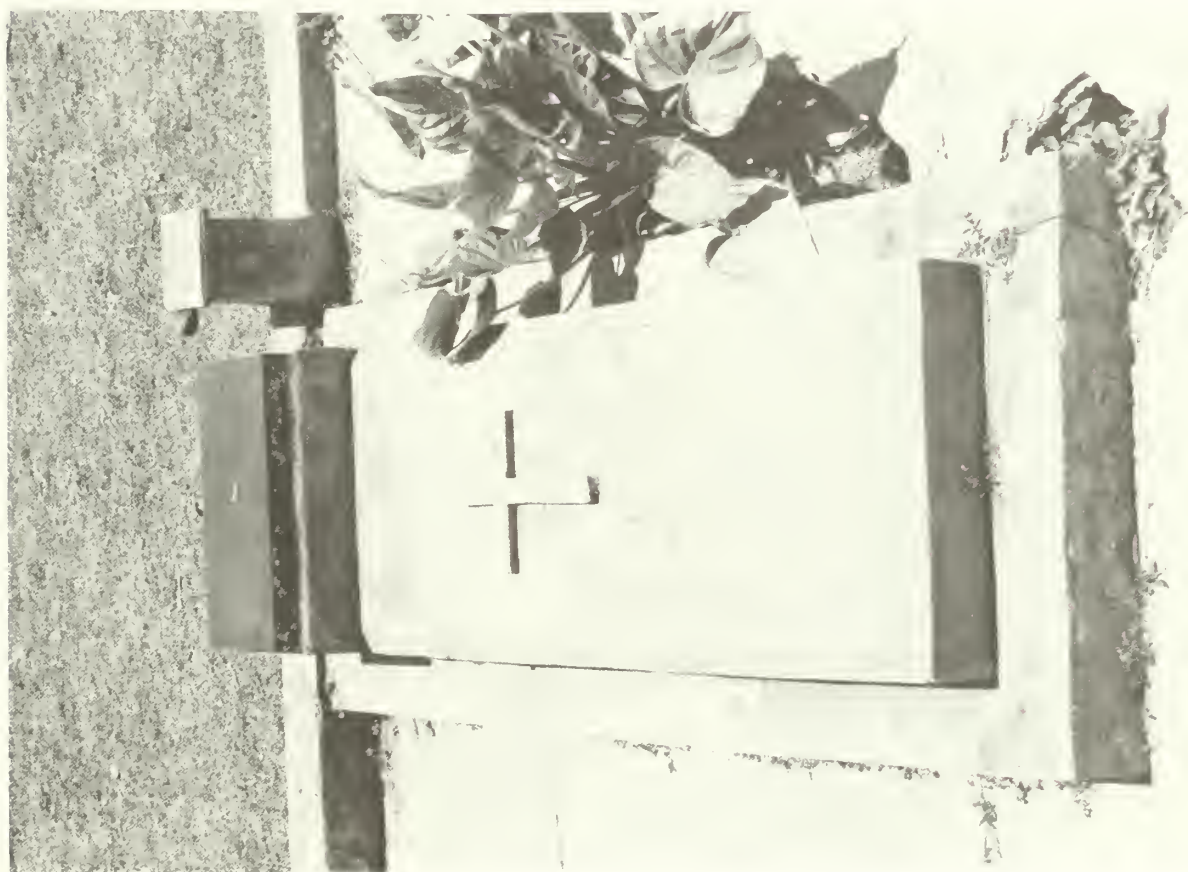
Illustration A138.

Grave of Br. Severin Baltes, Sept. 19,
1921 (No. 15D on Site Plan drawing).
8/84. P.C.C.
